# THE OAK CREEK DEBRIS FLOWS OF JULY 12, 2008, INDEPENDENCE, INYO COUNTY, CALIFORNIA

Dave Wagner, California Geological Survey

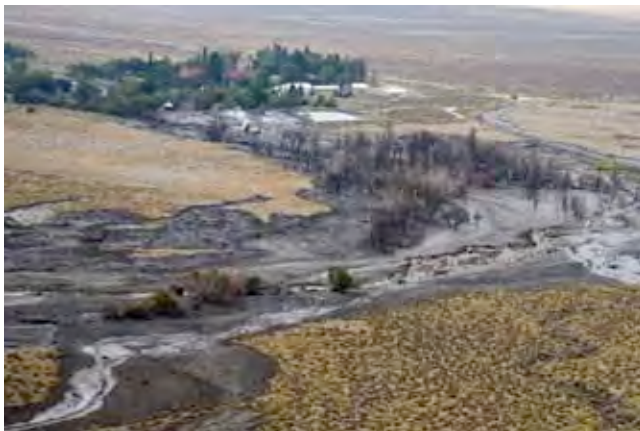
Mud along north fork of Oak Creek. Mt. Whitney Fish Hatchery in the background. Photo by Ken Babione

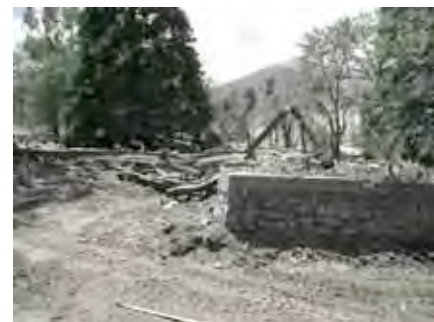
Remains of the main house at the Bright Ranch on the south fork of Oak Creek.

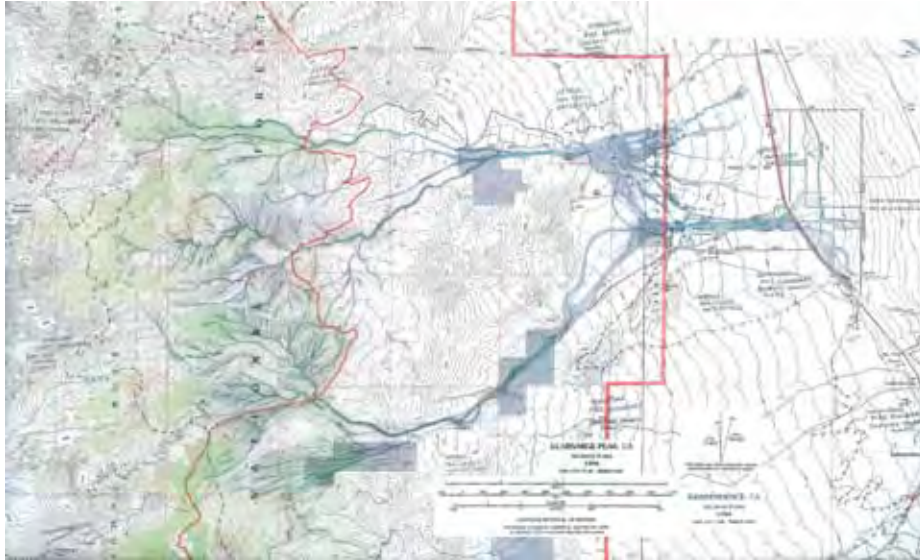
**Map of the Oak Creek water-sediment flows of July 12, 2008 and their source areas.**

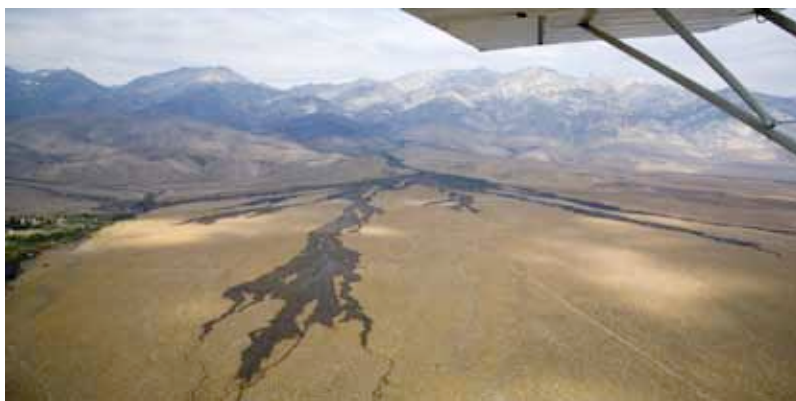
**Hyperconcentrated flow from the North Fork of Oak Creek. The Mt. Whitney Fish Hatchery is at the left side of the photo. Flows from the north and south forks of Oak Creek merged just upstream from the hatchery. Photo by Ken Babione.**

Water and sediment moved down the narrow canyons of the North Fork drainage as a hyperconcentrated flow (40-70 % sediment by weight). At the apex of the fan of the North Fork of Oak Creek the channel turns sharply south and the flow spread across the fan carrying boulders, logs and trees. Flows continued down the channel of the North Fork of Oak Creek which turns east and heads for the Mt. Whitney Fish Hatchery. Just upstream from the hatchery, the debris flow (70-90% sediment by weight) from the south and north forks merged and headed east through the hatchery and destroying homes. Flows then crossed Highway 395, passed through the Ft. Independence Reservation and came to rest in the flat lands west of the Los

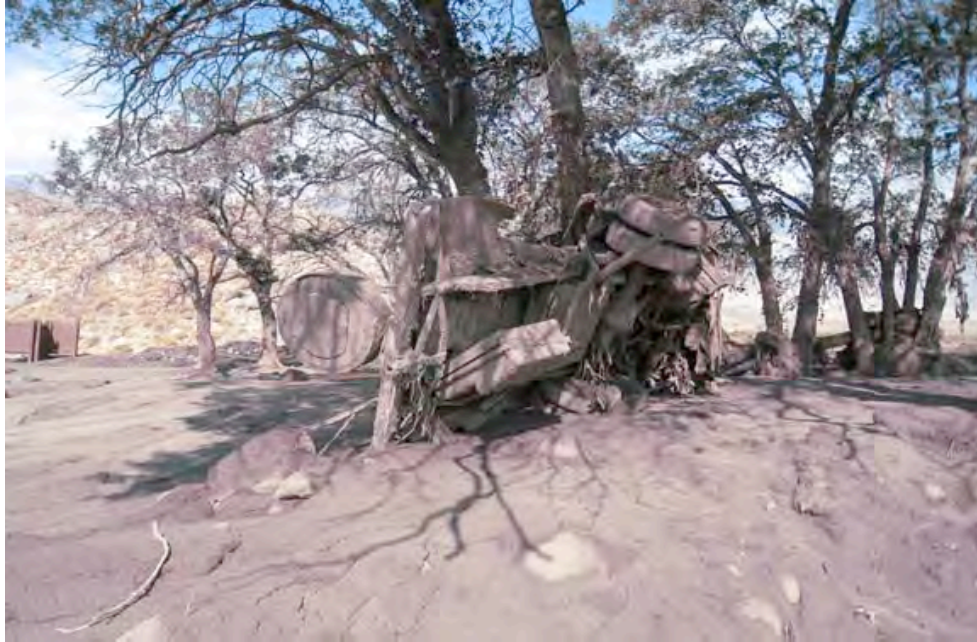
**Remains of Don Rockwood's motorhome.**

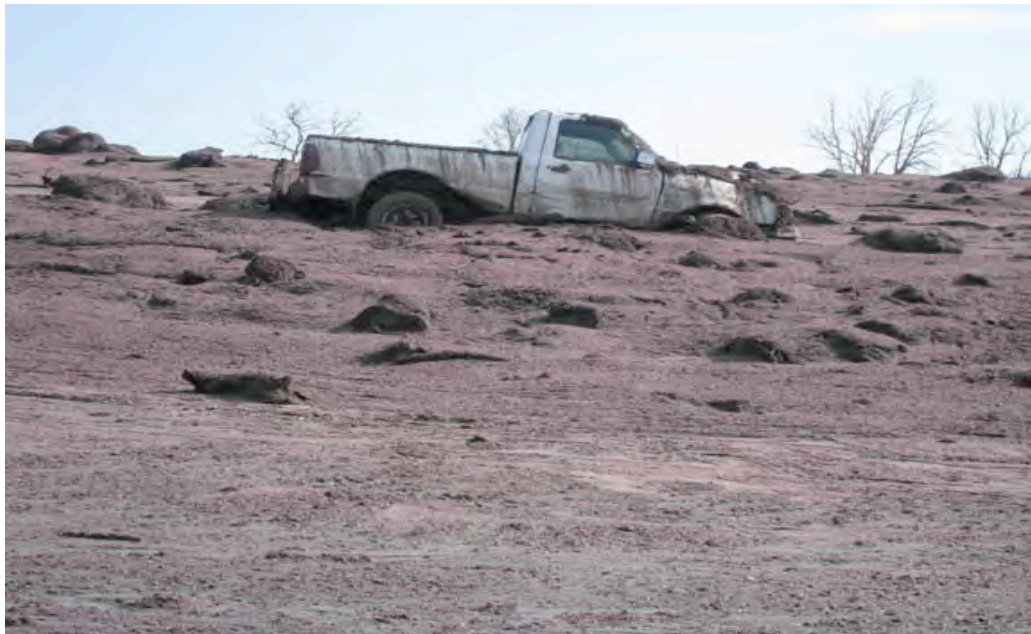
**Don Rockwood's truck**

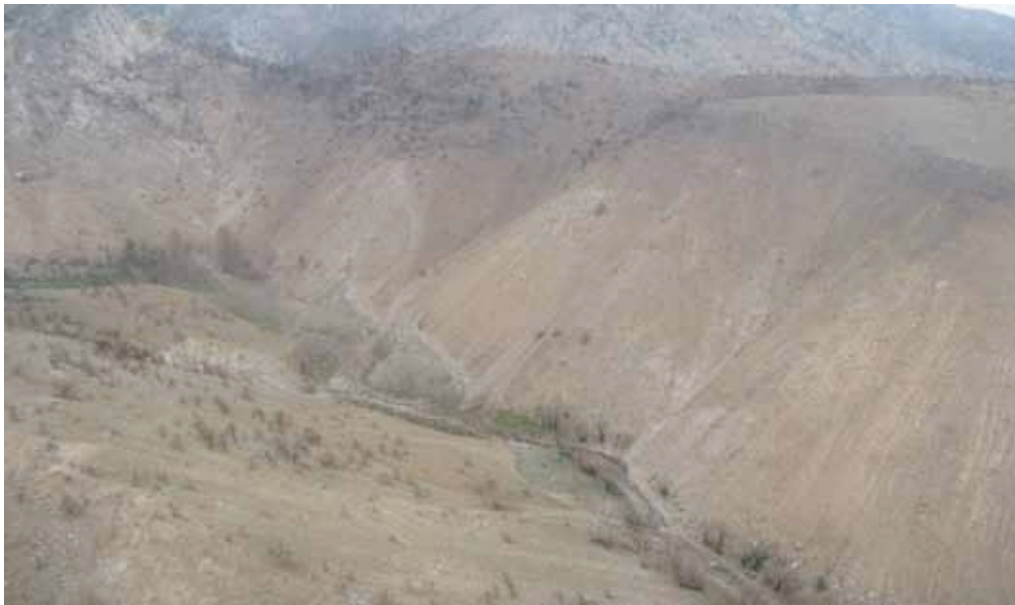
**Rilling of slopes in Charlie Canyon. Photo by J. DeGraf, USFS.**

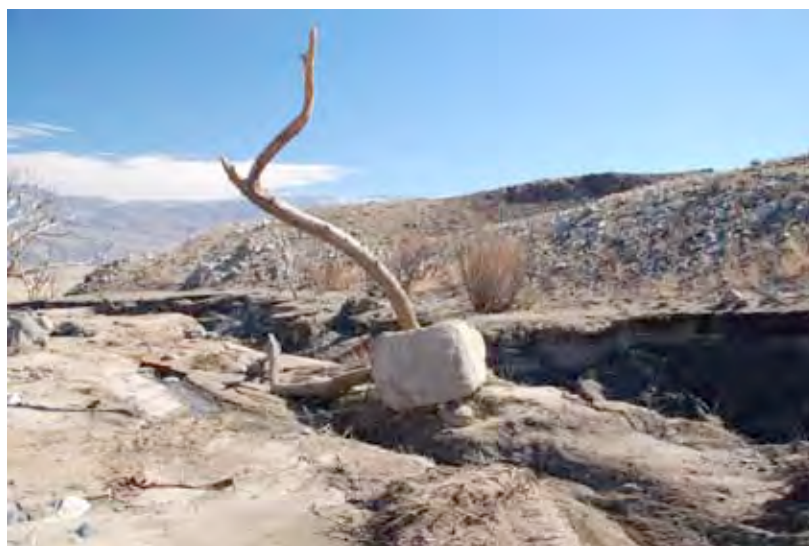
**Granitic boulder (~1 cubic m) that came to rest against a tree trunk on the middle Fork of Oak Creek.**

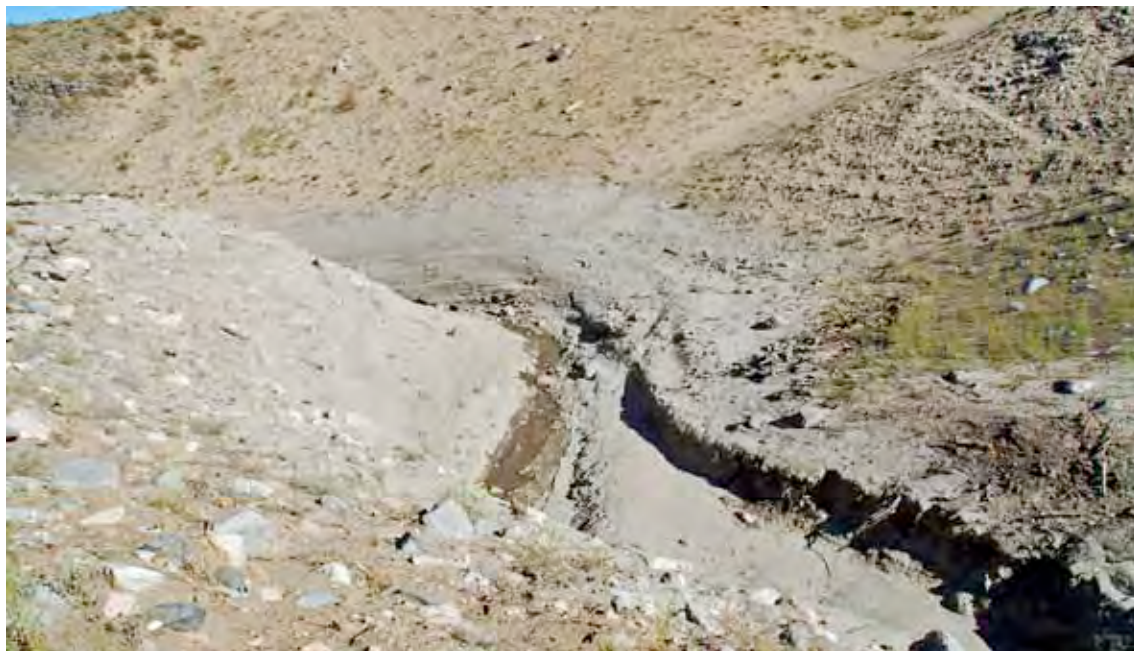
The largest single source area for the flow is drained by an unnamed tributary to the North Fork of Oak Creek, here informally referred to as the middle fork of Oak Creek. Extensive rilling occurred on the slopes at elevations mostly between 2000 and 2800 m. Deep incision and scouring in the middle fork is apparent above 2200 m elevation and becomes more pronounced downstream. Below 2000 m elevation incision is typically 5 to 15 m; usually bedrock is exposed at the thalweg. Headward and sideward erosion in the form of slumping is ongoing. Deposits exposed in the walls of the new channel are both fluvial boulder gravel and alluvial debris flows attesting to a history of events such as this one. Calculations based on run-up (superelevation) around channel bends suggest the largest surge was traveling about 12 miles per hour

**Bends in the channel of the middle fork of Oak Creek where speed of the flow was estimated by measuring run-up (superelevation).**

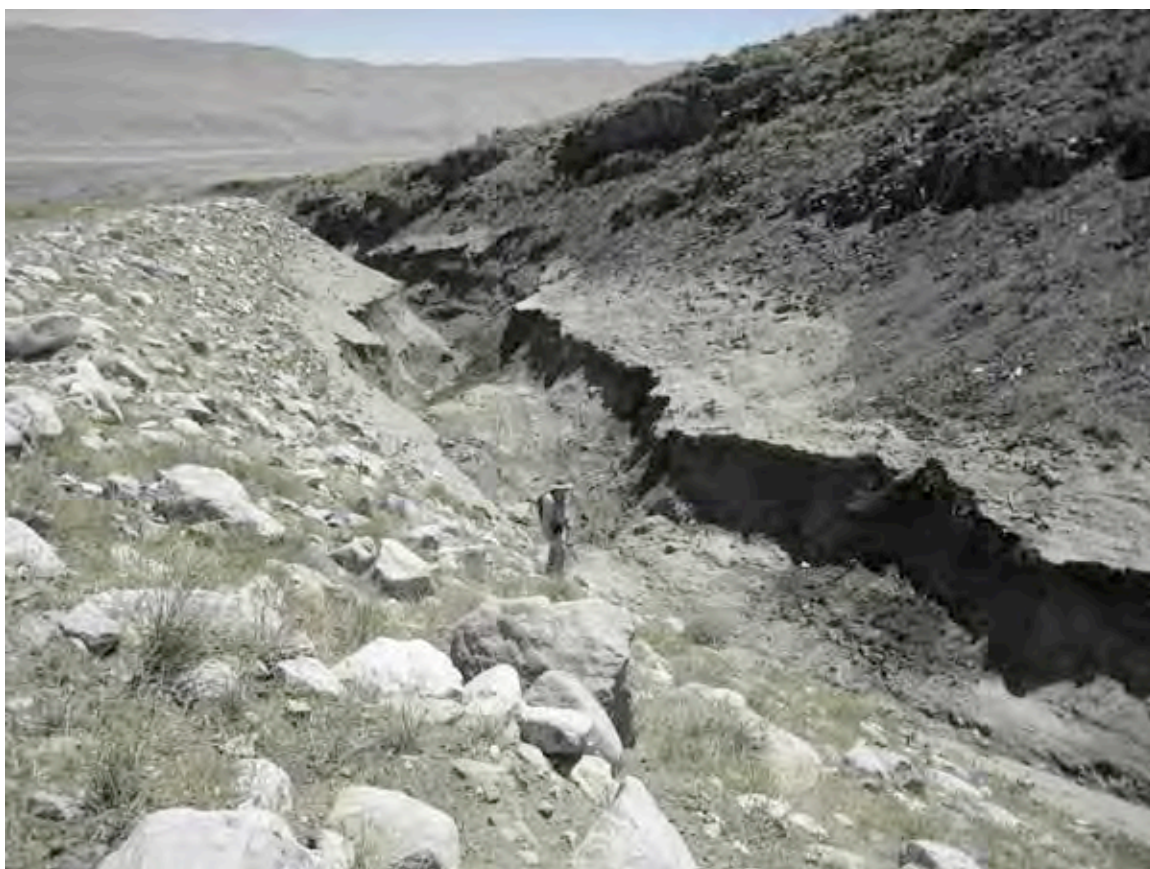
**Deeply incised channel of the middle fork of Oak Creek. Note run up of mud above the new channel.**

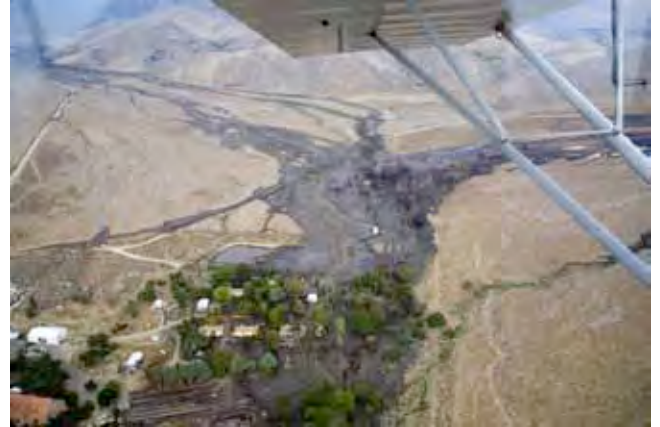
Sediment from north and south fork of Oak Creek merged west of the Mt. Whitney Fish Hatchery. The South Fork of Oak Creek was forced into a new channel closer to the mountain front. The old channel marked by vegetation near the top of the photo is now abandoned. A second avulsion caused sediment to flow across the fan of the south fork but it eventually joined Oak Creek just west of the fish hatchery. Photo by Ken Babione

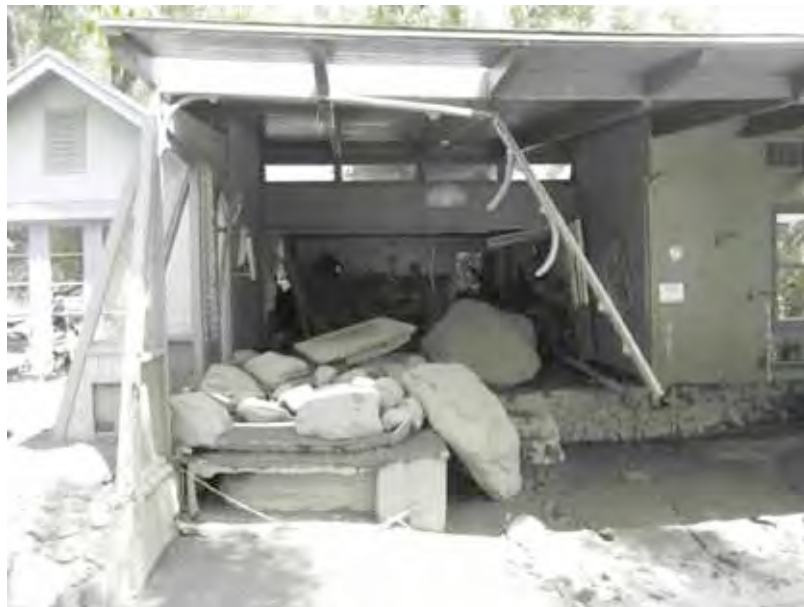
Twenty-five homes along Oak Creek just east of the Mt. Whitney Fish Hatchery were reportedly destroyed (Inyo Register, July 15, 2008). They were situated very close to the creek and were battered by boulders and logs.

Home destroyed along Oak Creek

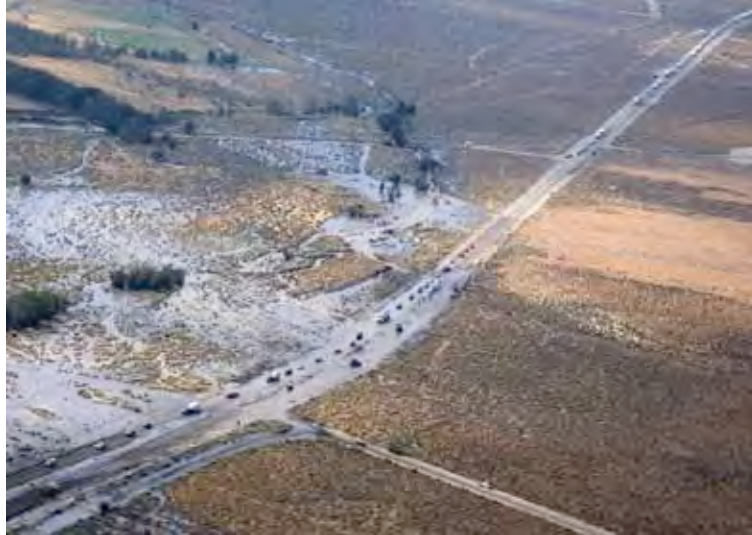
Mud and debris filled the Oak Creek channel and new channel was established to the south. The creek was diverted back to its original channel soon after the event by CALTRANS allowing residents to reach their homes. Mud flowed across Highway 395 and through the Ft. Independence Indian Reservation damaging another 25 homes. Mud and water flowed across the highway for days requiring traffic detours or escorts to pass through the area.

**Mud flowing across Highway 395 requiring CHP escorts to guide traffic through.**
